## Background

Near Parewanui, the Rangitikei River meanders, eroding the west bank. Flooding during Cyclone Gabrielle accelerated the erosion, and the river almost reached the stopbank.

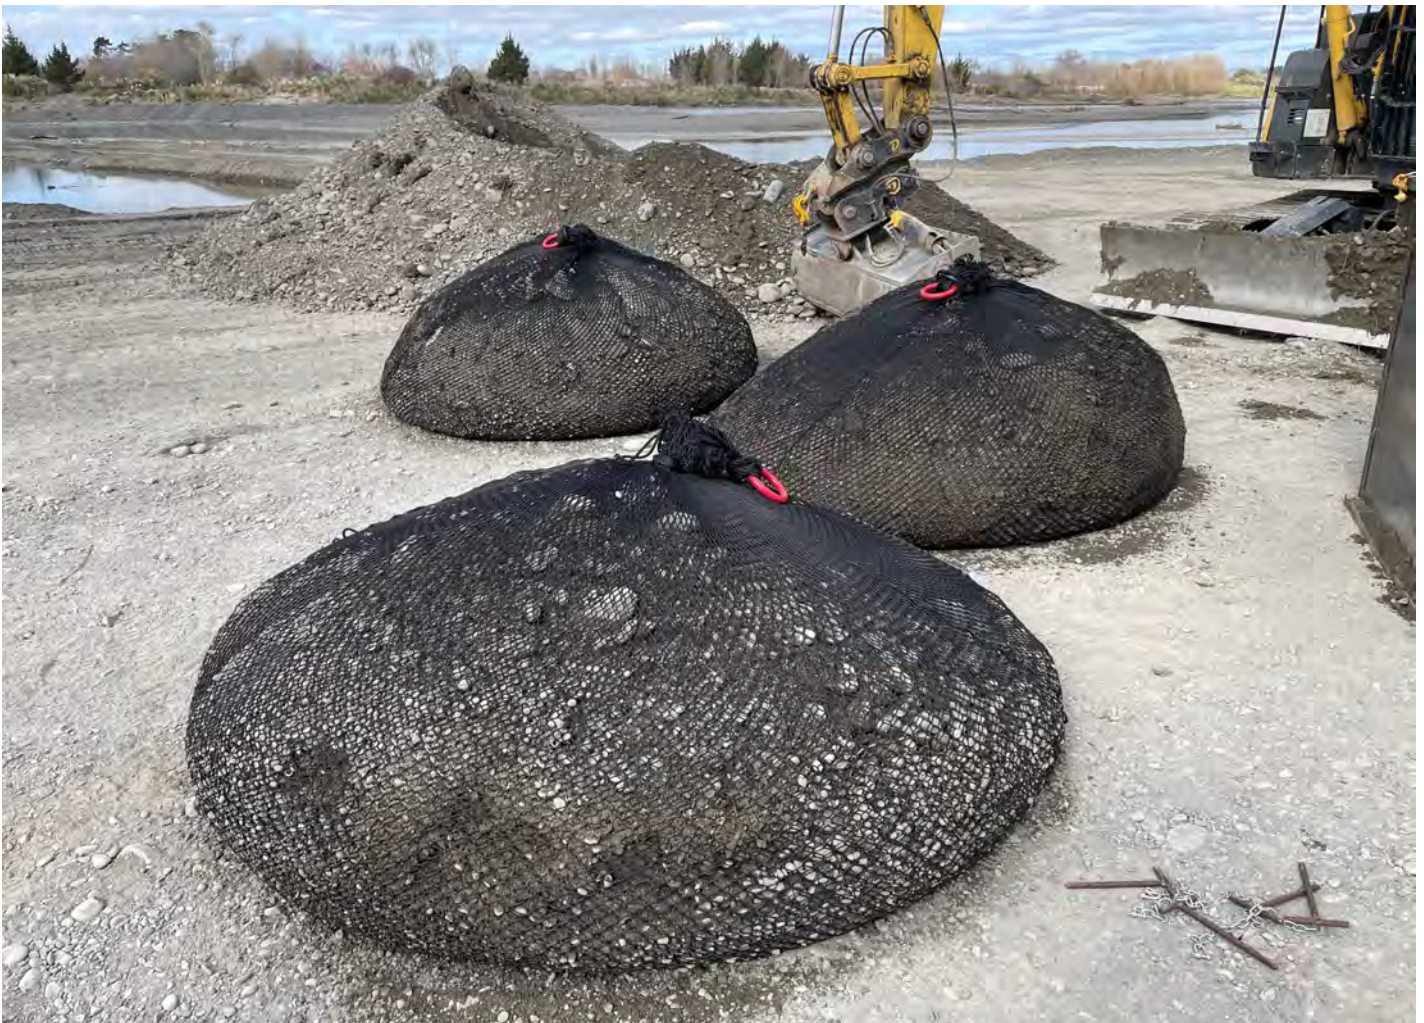
Fortifier Erosion Control Rock Bags were filled with local, ungraded river run material, with rock size ranging from sand up to around 300mm. (4 tonne Rock Bags pictured.)

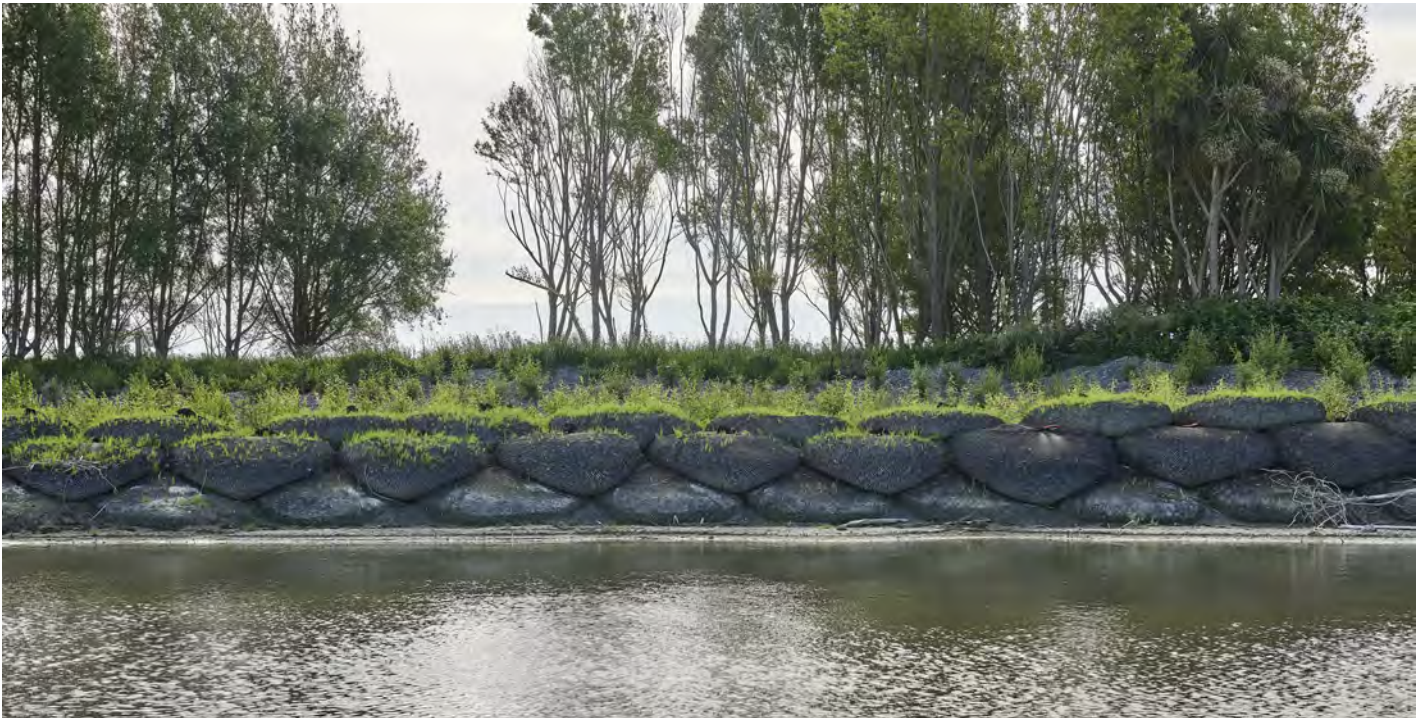
A row of 4 tonne bags was placed at the toe, and 2 tonne bags layered above, staggered in the staircase method.

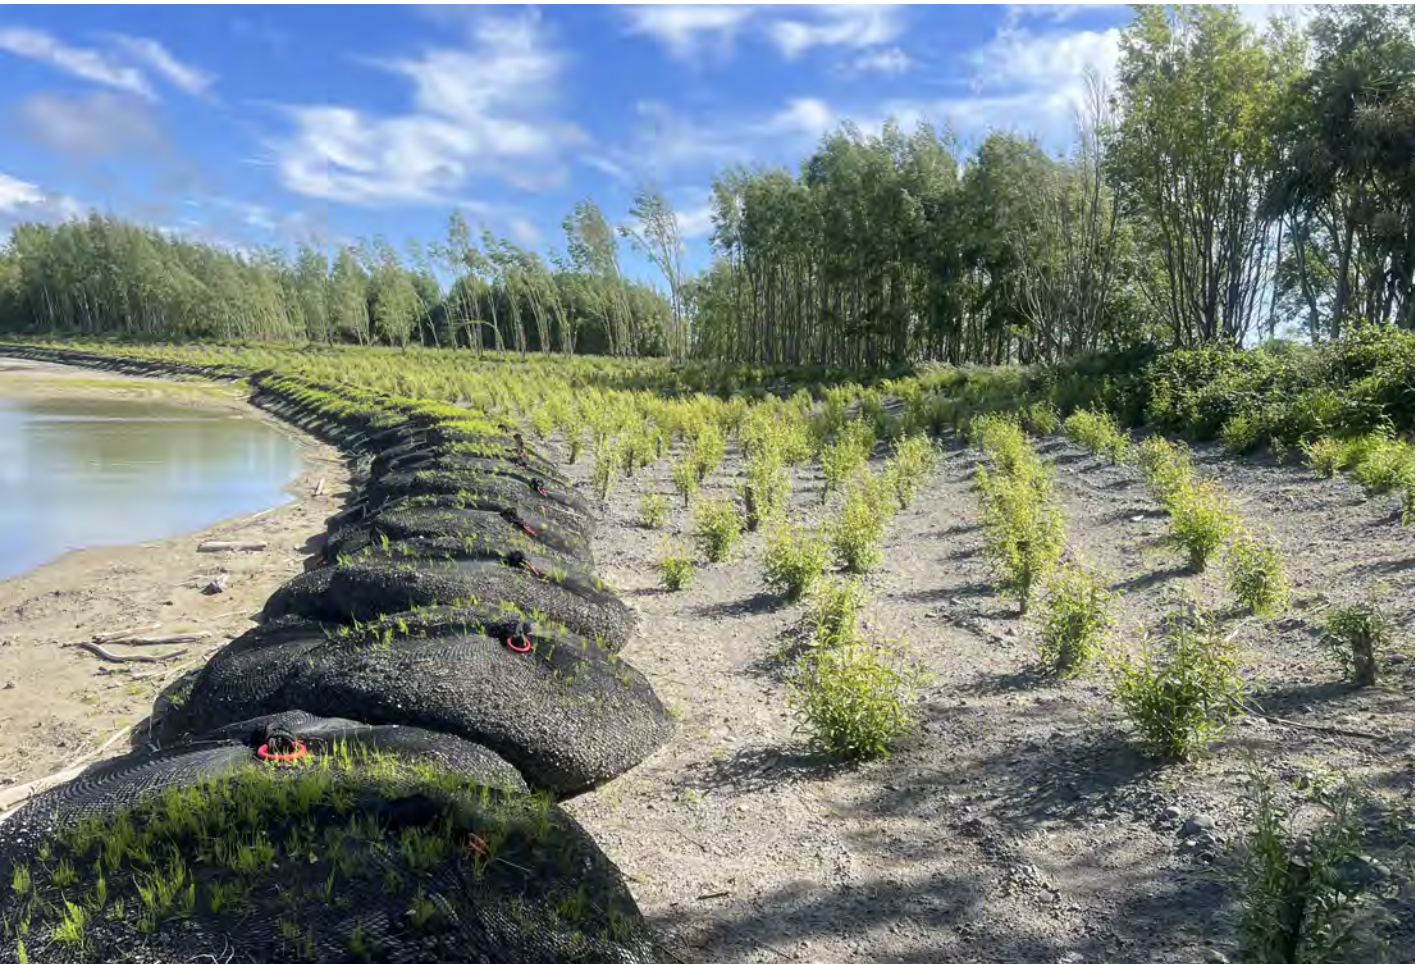
The damaged section of river bank was filled and planted with Willow trees, with the Rock Bags positioned to take the brunt of the river's impact, shielding the plantings while they mature.

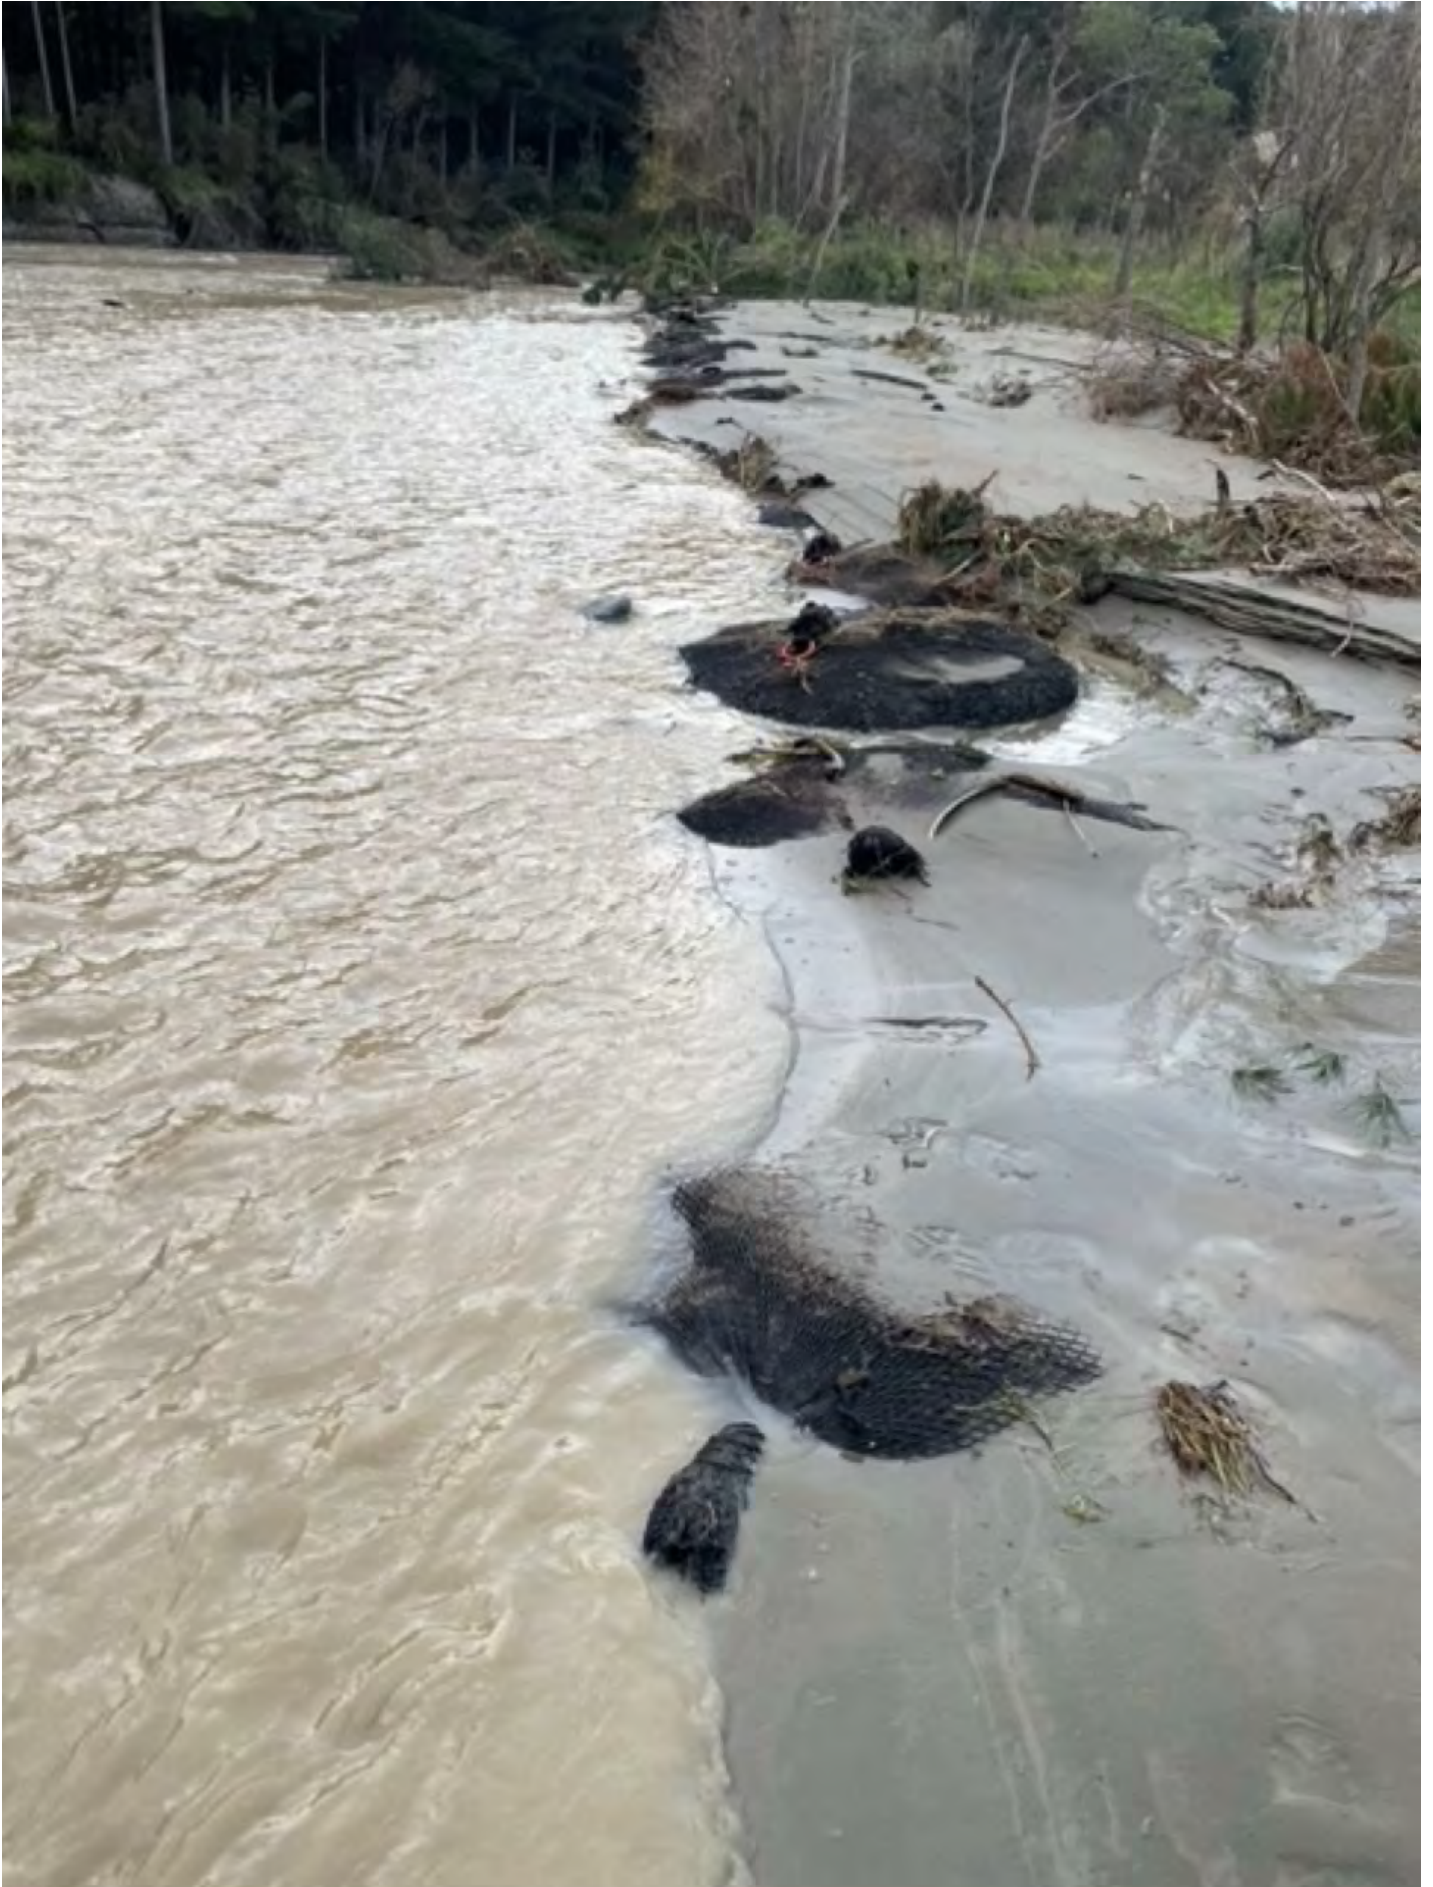
This image is from a different installation, however it illustrates how flow velocities are slowed greatly around the Rock Bags, allowing silt to be deposited.

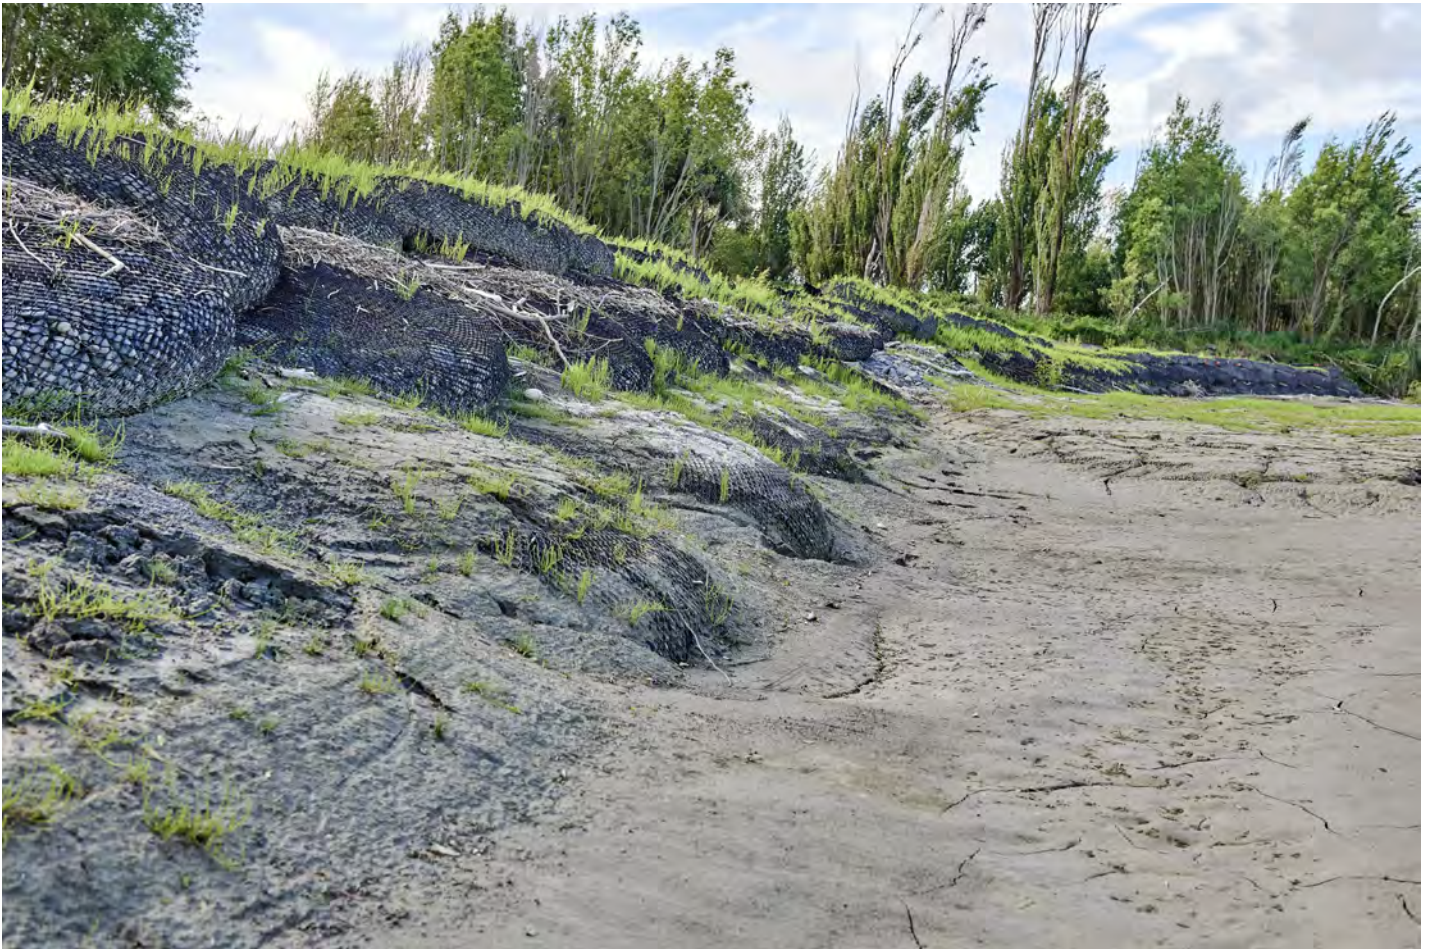
After several high water events, the Parewanui installation has settled, and silt buildup has begun.

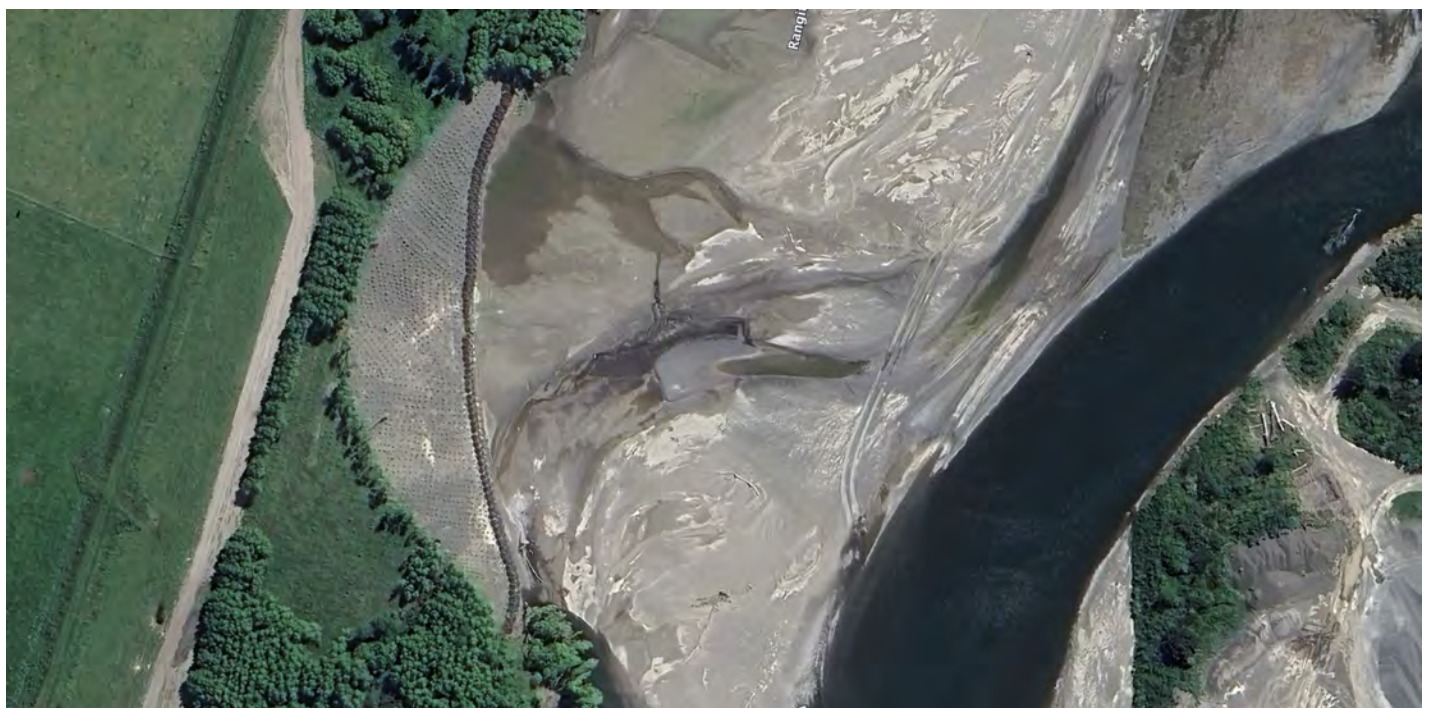
This satellite image some time after the repair was completed shows that the Rock Bags have done their job perfectly, withstanding several floods, and assisting the main channel to meander away again.

Note the white patches visible amongst the willow plantings where the river has inundated the repair, depositing silt, but not eroding.

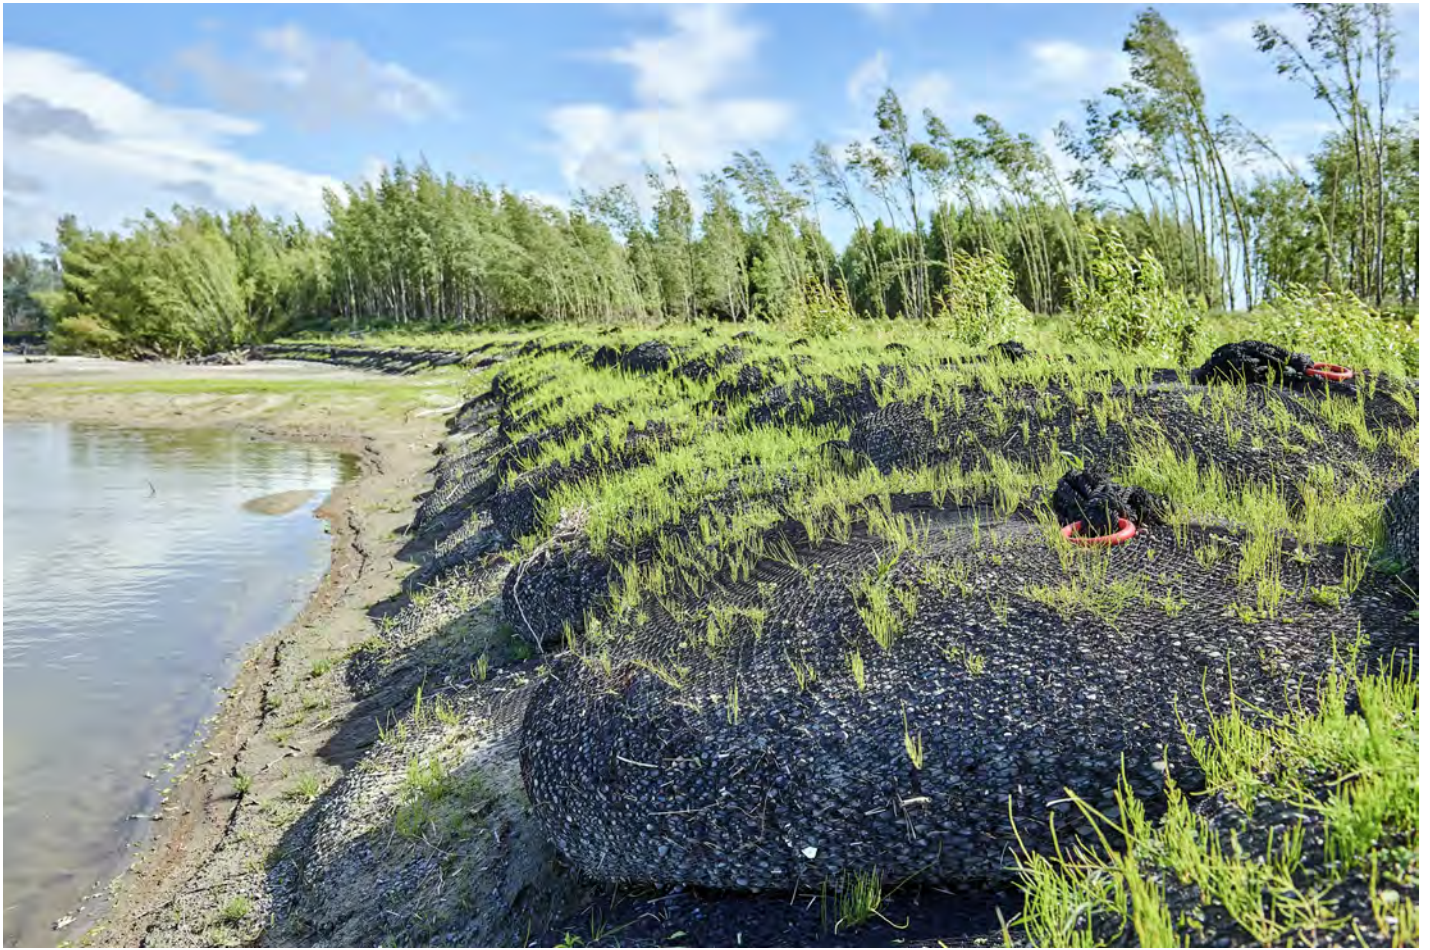
Nursery plants and grasses have also naturally begun to grow within and through the Rock Bags.

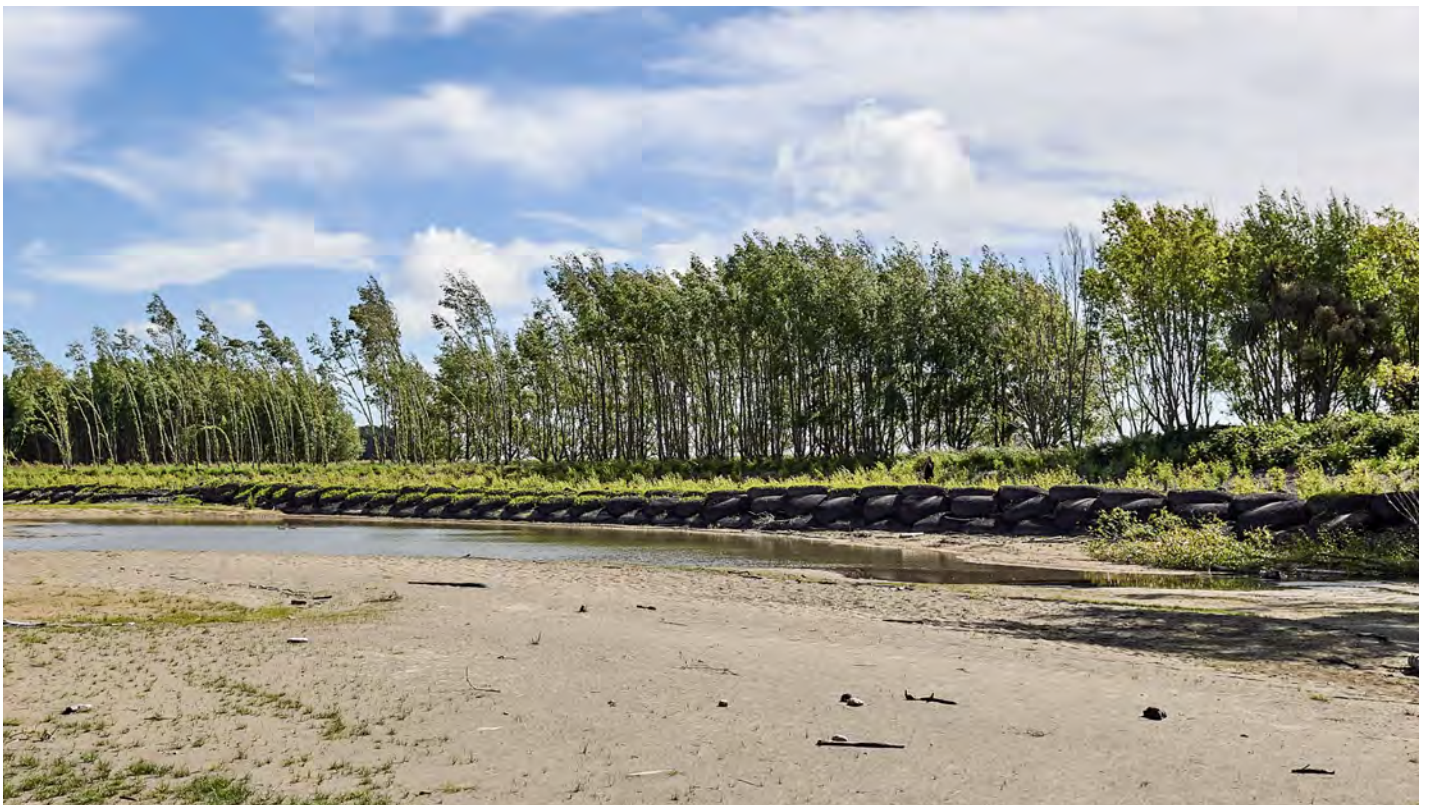
Root systems will tie bags together and further contribute to bank retention. Eventually, the bags will be covered and integrated into the habitat, assisting stability and promoting rejuvenation of the damaged area.
