Background

Porewa Rock Bag Installation

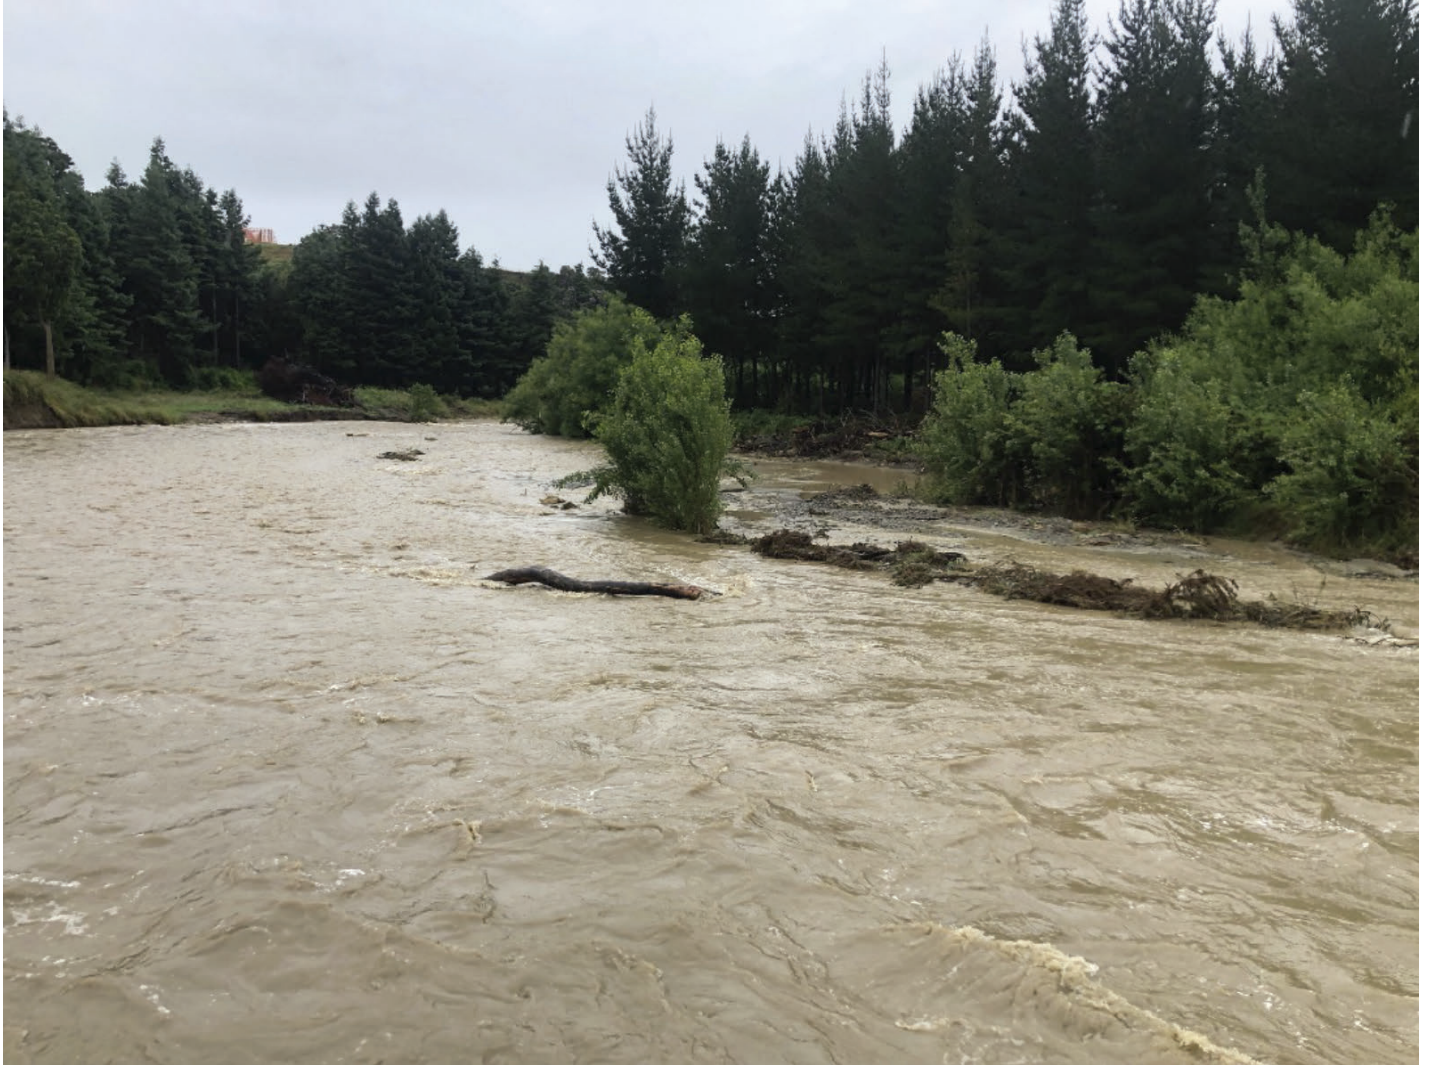
The cliff on the left is four metres high, and the original stream bed can be seen in the extreme right of the photo. This stretch of riverbank has been problematic in the past, but not to this scale.

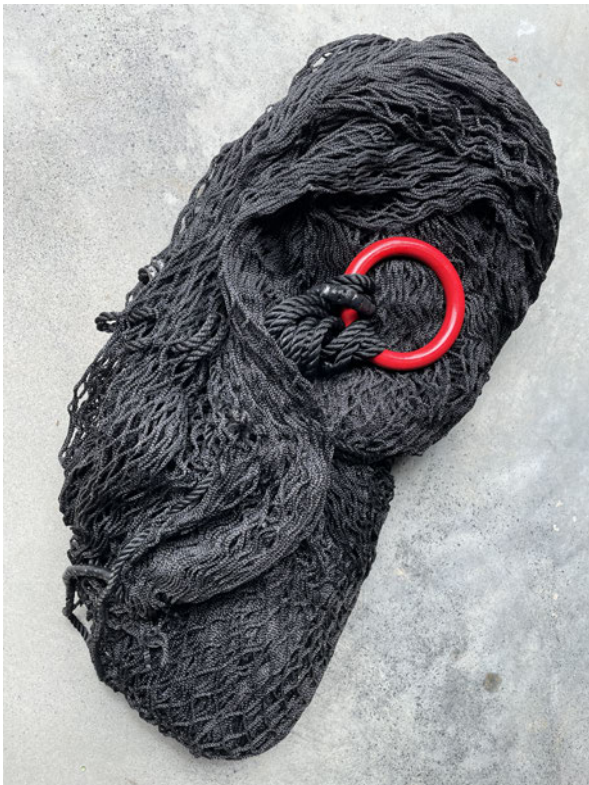
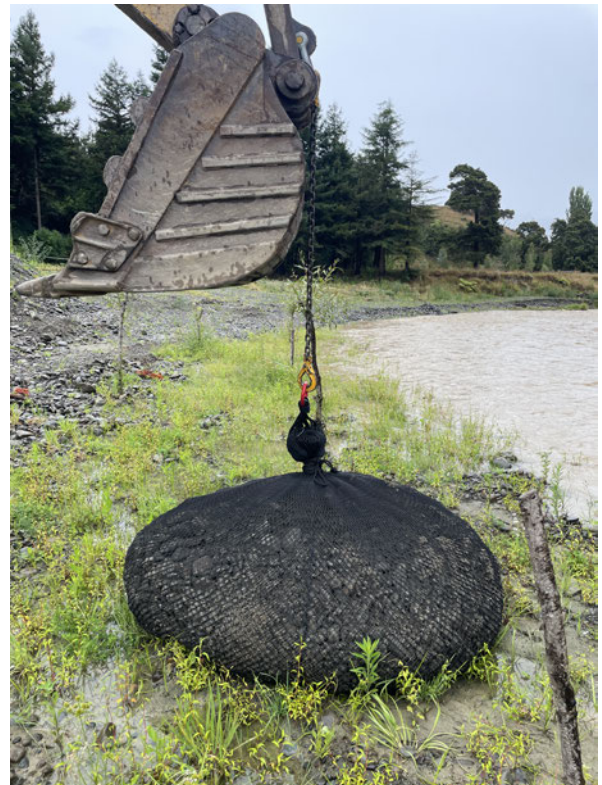
These bags are manufactured with double-layered, 25mm polyester mesh, and can be filled with rocks, riprap, graded metal or even river run (depending on sand content). Several bag weights and mesh sizes are available.

No bed preparation is required, and they are quick and simple to fill and place. Once placed, the bags can be covered with dirt, and plantings utilised to assist their assimilation into the local environment.

After spending large amounts of time and capital on what are effectively temporary repairs, we reached out to a company in China to see if we could manufacture a product which would suit our application. 150 two-tonne “Rock Bags” were specified and procured, as they are a well-established, highly effective, and eco-friendly product.

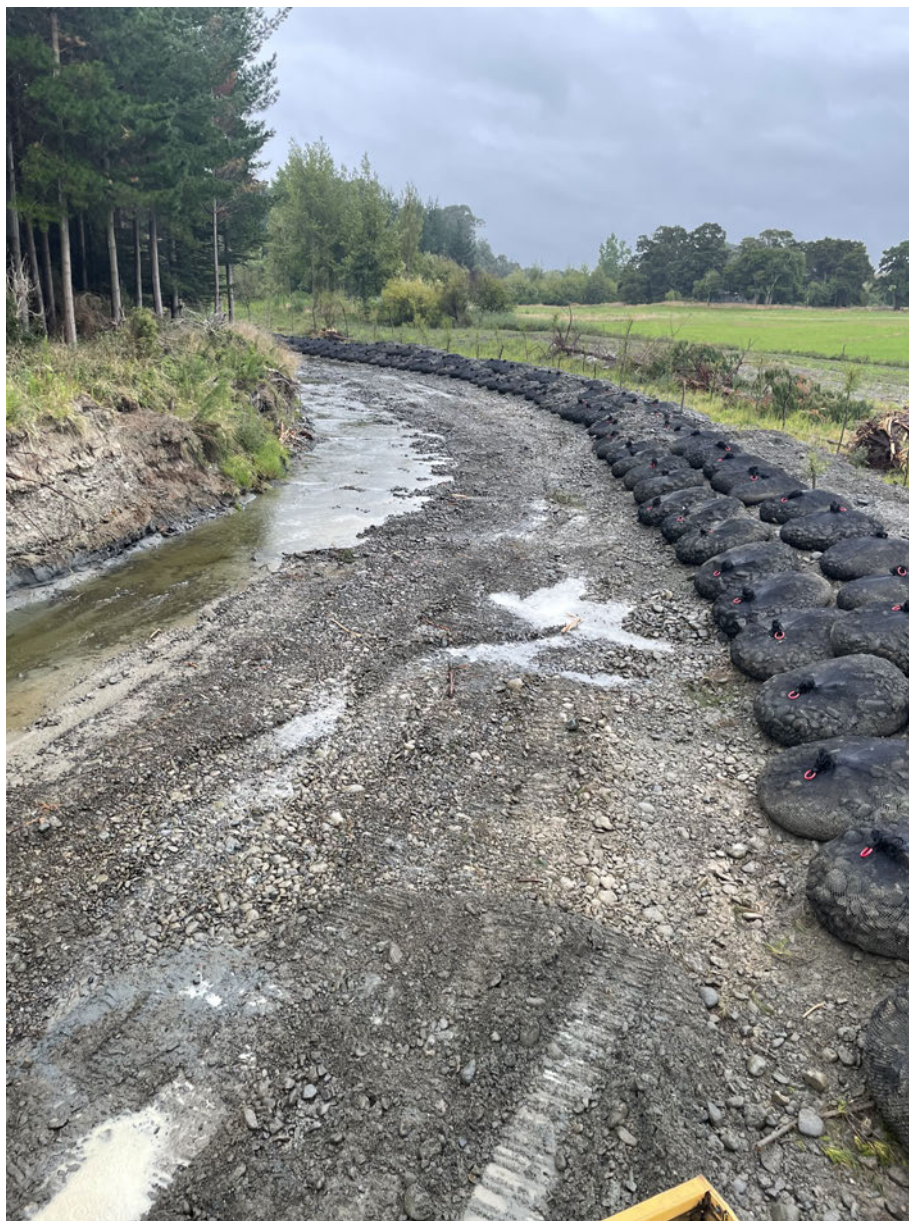
There are several methods of placement; in the photo below, the bags have been placed on a shallow stop bank using the “pancake” method, which provides the greatest coverage. Once filled, the 2T bags are about 2m in diameter, and 0.6m high.

In the week before Tropical Cyclone Gabrielle struck, the bags were filled and placed, utilising river run from on site.

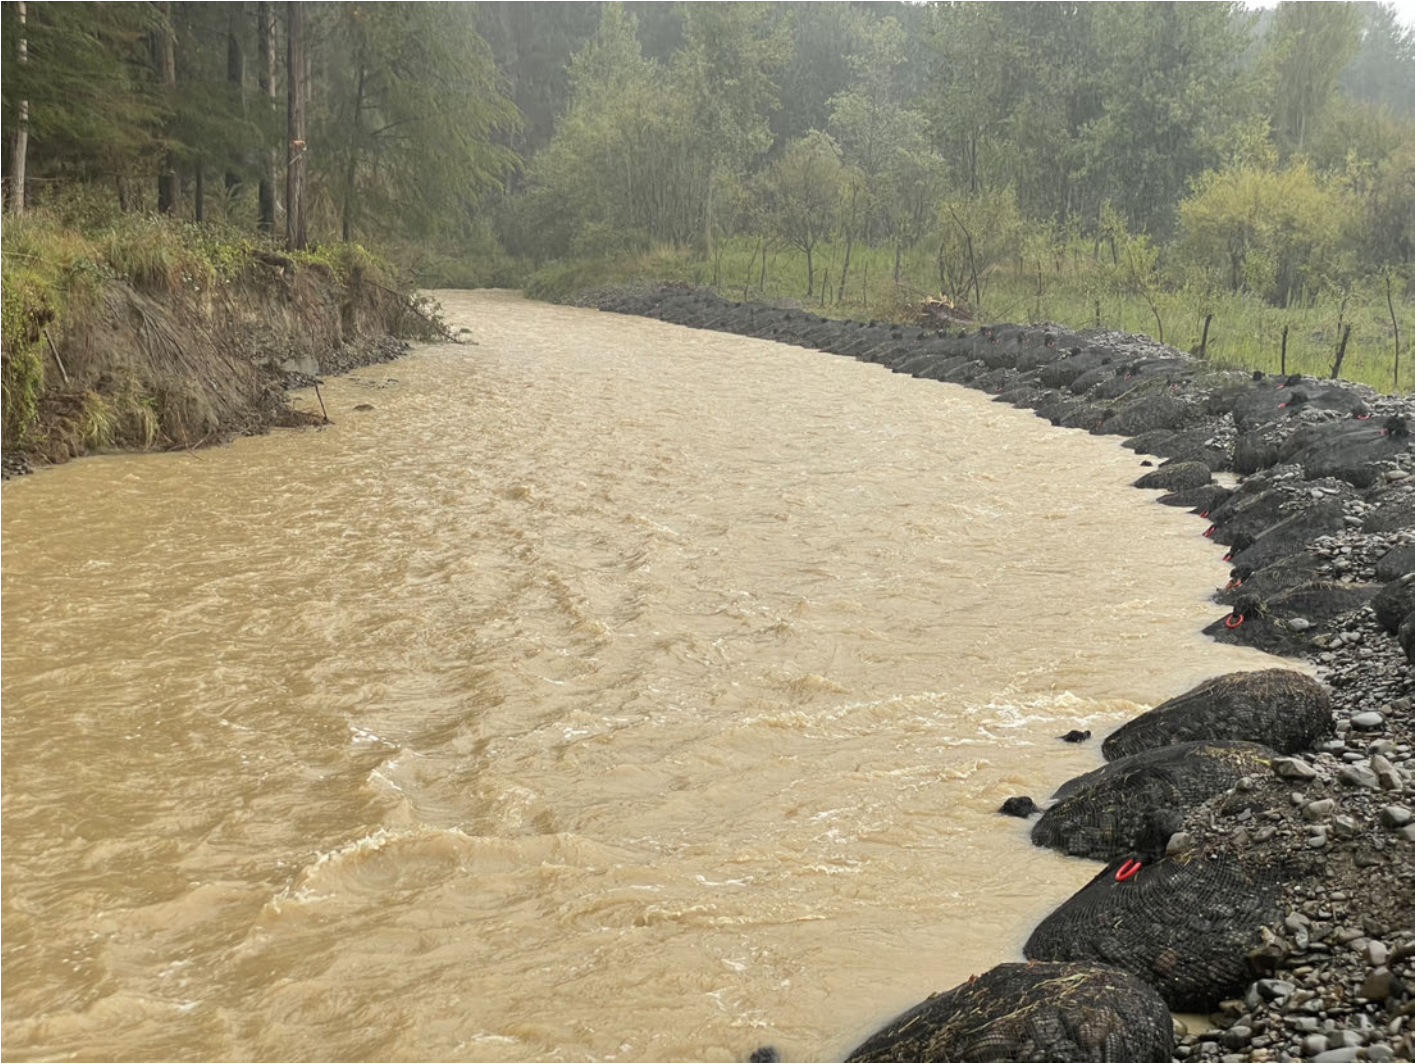
The photo below shows the water rising, about a day before its peak level.

Of note is that although the stop bank visible here is only a pile of loose river run, the Rock Bags prevented erosion, enabling it to contain the stream during a large flood. Without them, the recently planted willow trees and other vegetation would again have been wiped out.

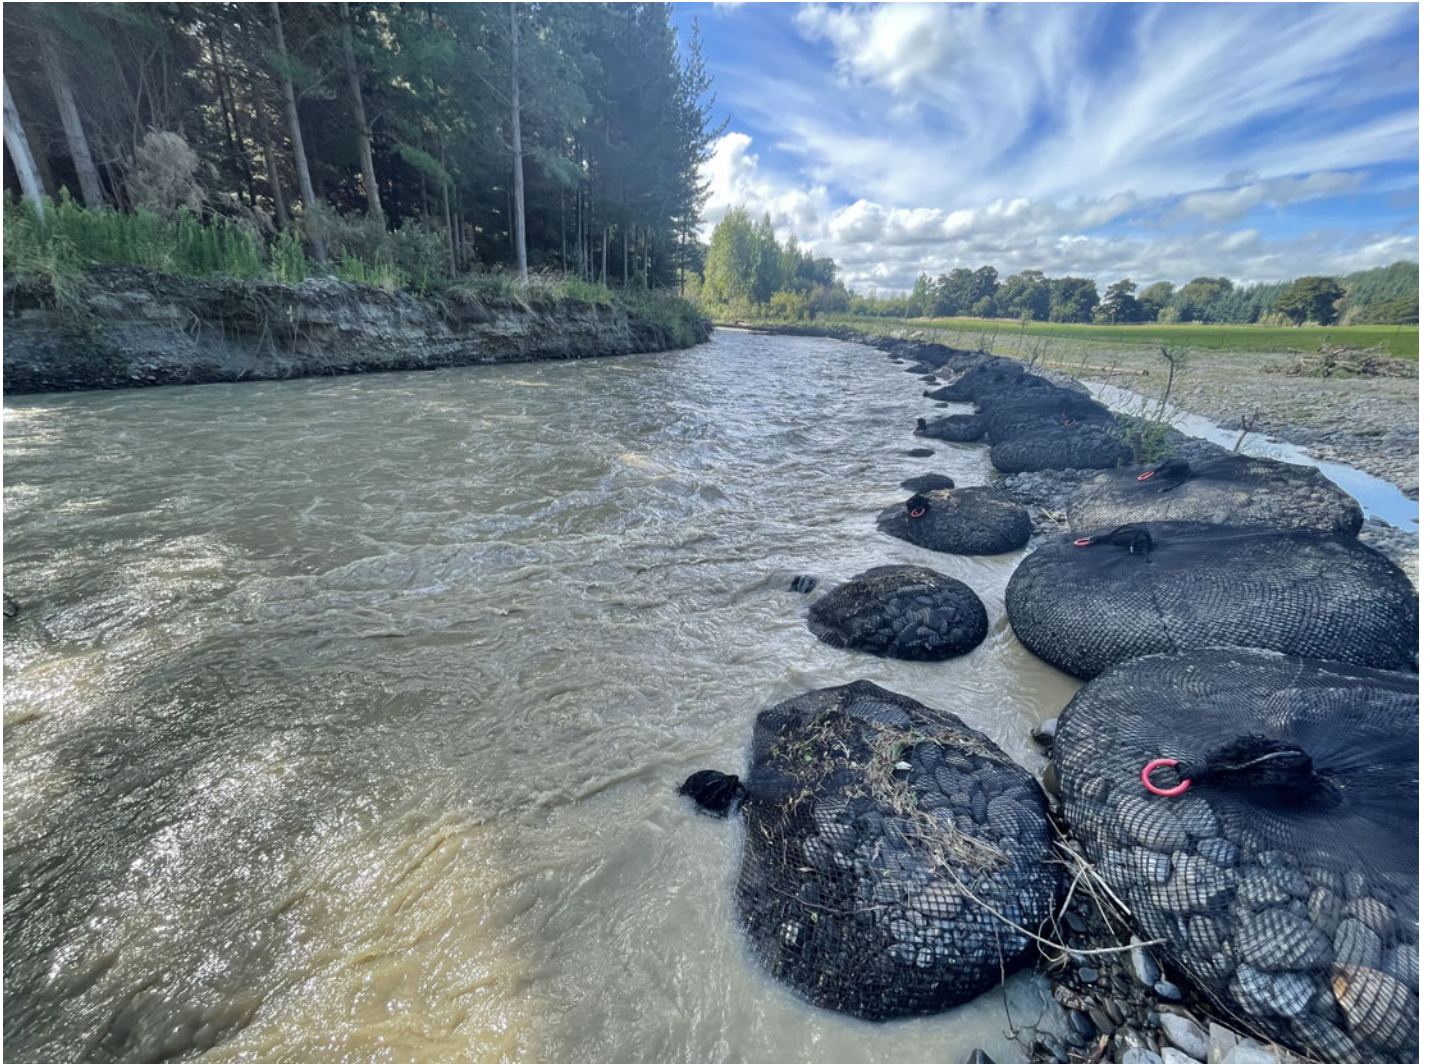
This photo was taken the day after the peak flood level (the tide mark is evident in the foreground). The water level is around a meter above the ground level visible on the right of the image.

Note that some bags have slid into the stream slightly. This is one of the unique features of Rock Bags; they slide or droop into erosion points, filling the localised damage, and preventing or mitigating further erosion.

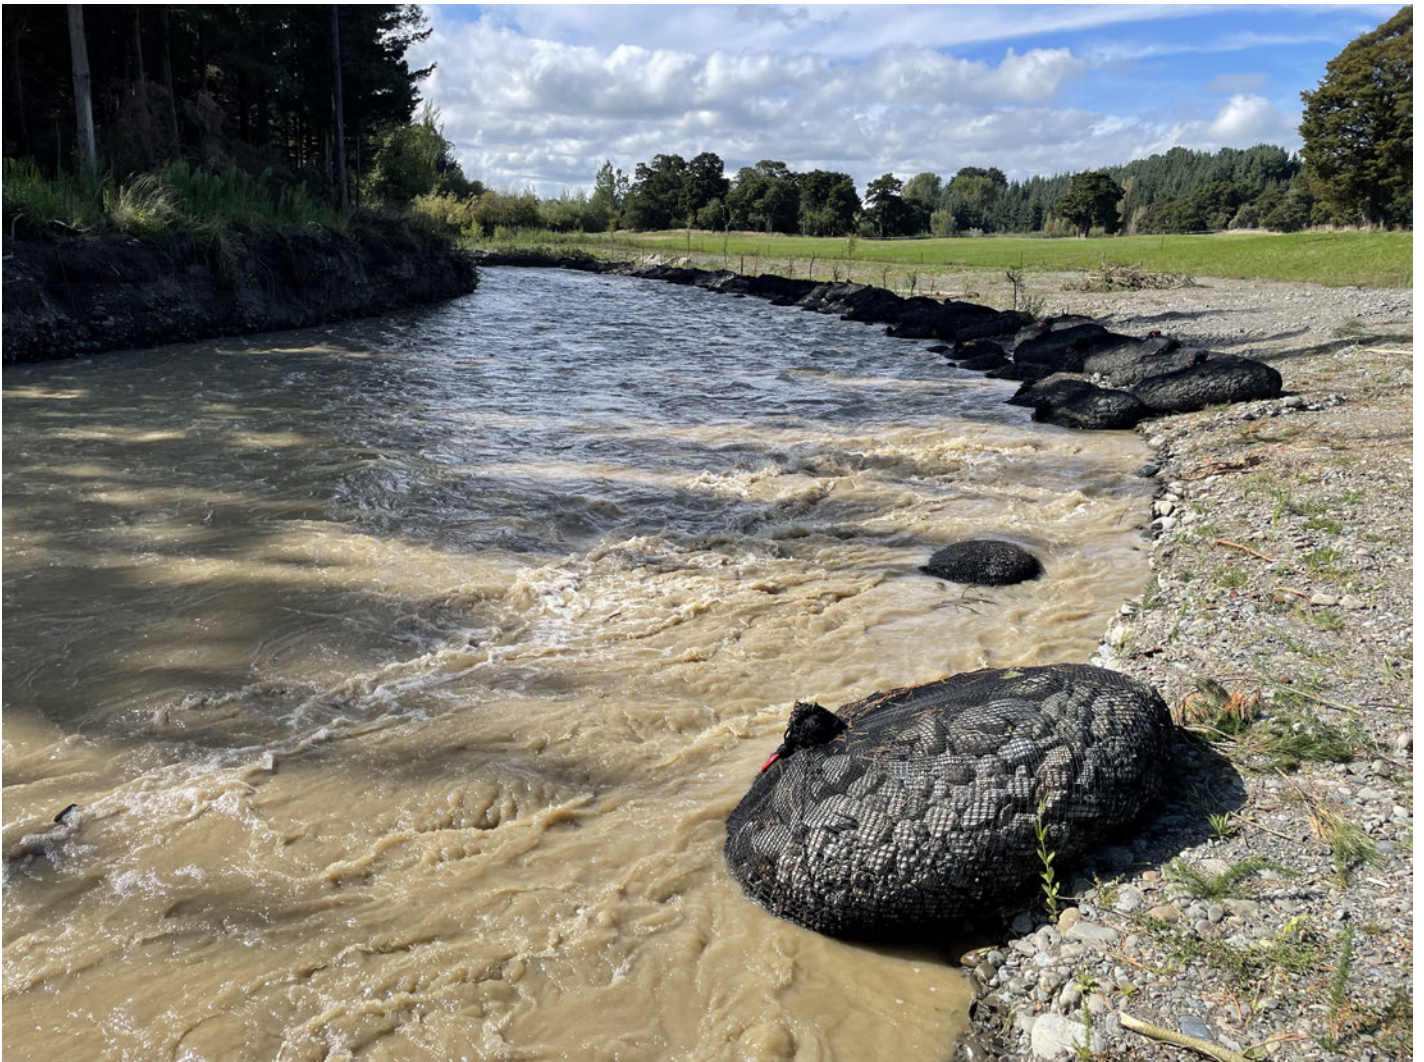
Only a single row of Rock Bags was placed at the end of the vulnerable section of riverbank, however even this was still sufficient to prevent any substantial bank erosion from occurring.
